Turnaround Disaster

Confined Space

Incident

- On March 27, 1998, at approximately 12:15 PM, two workers at a chemical plant, were overcome by nitrogen gas while performing a black light inspection at an open end of a 48-inch-wide horizontal pipe.

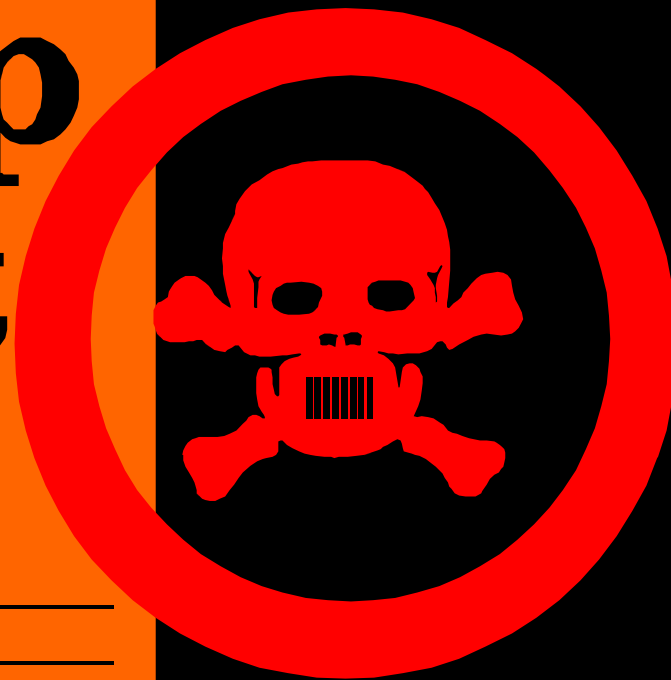
- While working just outside the pipe opening and inside of the black plastic sheet, the two workers were overcome by nitrogen. One worker died from asphyxiation. The other worker survived but was severely injured.
